# P-026

### SVE BULLETIN

Date: 1 March, 2017

### **2013MY and beyond Utility Police Interceptor Vehicle Modifications and Sealing**

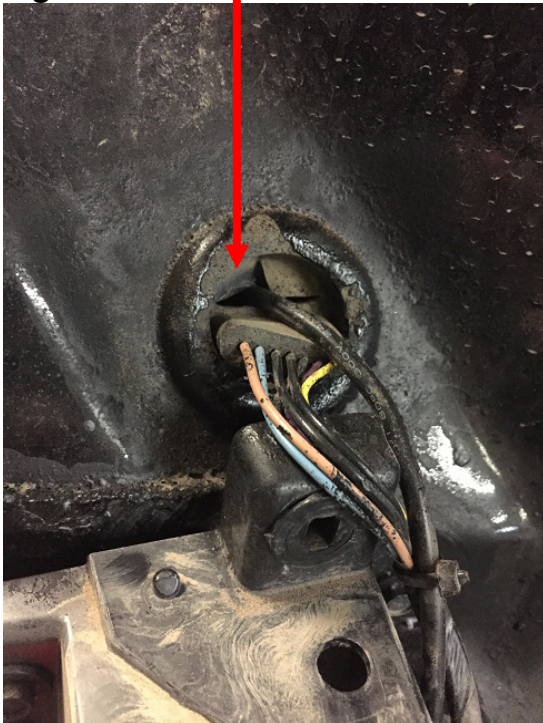
Figure 1

### Passenger Side Tail Lamp not properly sealed

- Any holes in the rear of the vehicle must be sealed
- Wiring pass-throughs, through sheet metal and/or existing grommets behind the passenger side and driver side tail lamps must be fully sealed using Motorcraft Seam Sealer (TA-2-B)

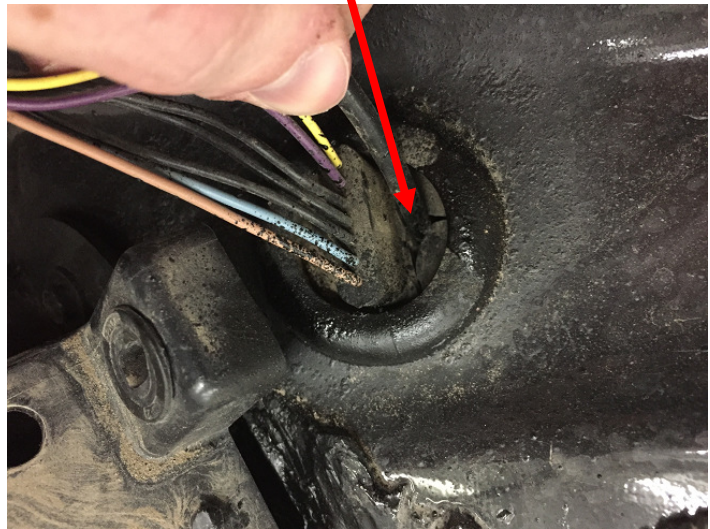
Figure 2

### Grommet not properly sealed

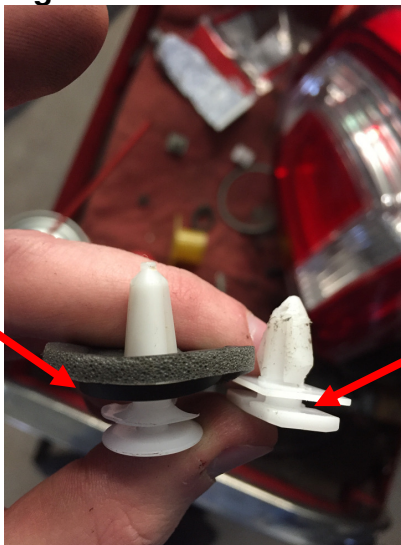
**Figure 4**

**CORRECT**

**INCORRECT**

- Replace any damaged plastic retainer clips with close attention to the foam gaskets.
- Repair any deformed sheet metal to ensure a good seal.
