SVE BULLETIN

QVM Bulletin: Q-266R1

2017 to 2020 Model year F-Series Dual/Single Alternator Conversion

Models Affected: 2017 and later F-Super Duty F-250/350/450/550 with dual alternators

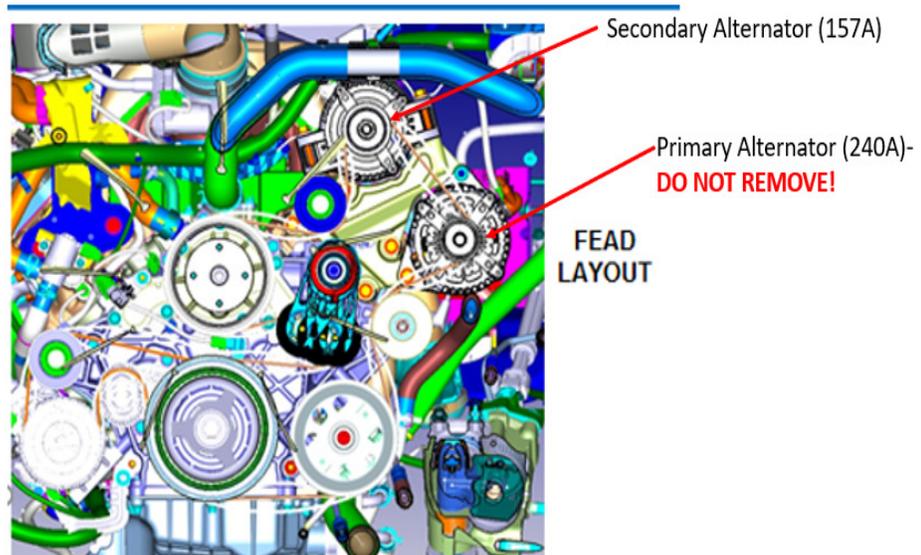
2020 P558 7.3L Gas Engine FEAD

If one of the alternators must be removed the secondary alternator must be chosen.
