SVE BULLETIN

QVM Bulletin: Q-282R2

2018 Super Duty Pickup Rear View Camera –Tailgate or Box Removal

Models Affected: All 2018MY Super Duty Pickups

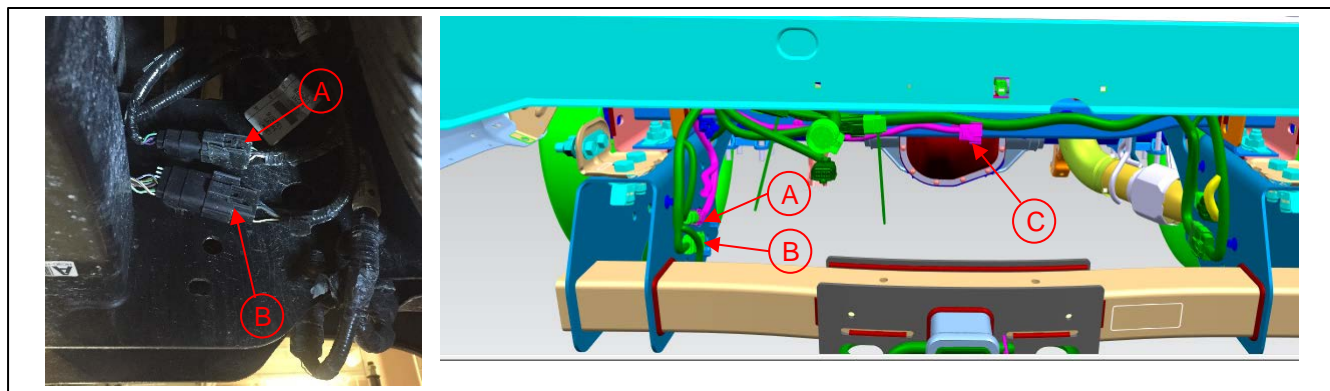
Figure 1: Tailgate camera harness location - jumper harness shown installed, with excess length stowed

Item	Description
A	Camera connector
B	Tailgate lock connector
C	Jumper Harness Connector (to camera kit)

Ford rear view camera kit **JC3Z-19G490-B** (see contents in Figure 3), can be installed following kit instruction sheet included in kit. The kit harness does not connect directly to rear camera frame harness – it will be necessary to install jumper **HC3Z-14B242-K** (see Figure 1 for location of jumper). Excess harness should be coiled and secured.

Note: Vehicles with power locking tailgate will have a second connector on the tailgate harness. To protect connector, install cap provided with vehicle (service part number 4W1Z-14489-BA)

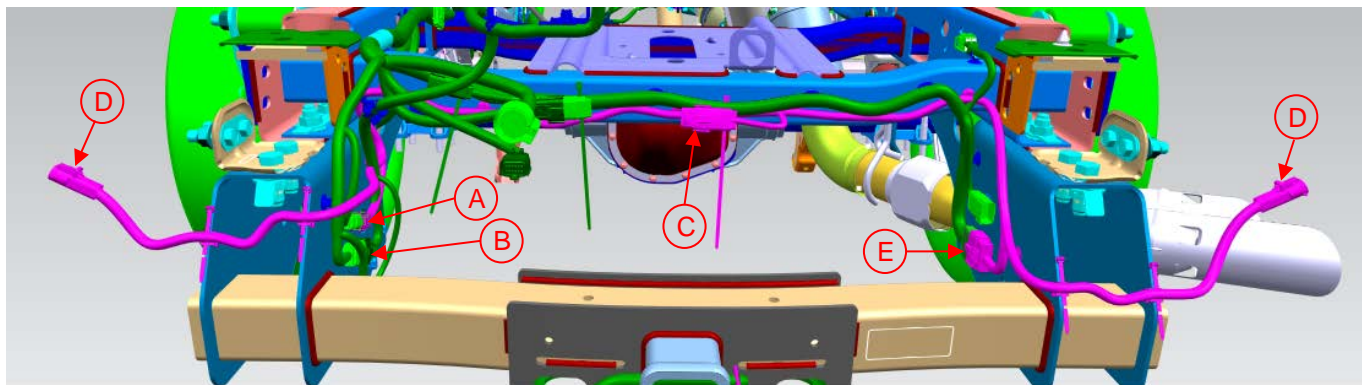
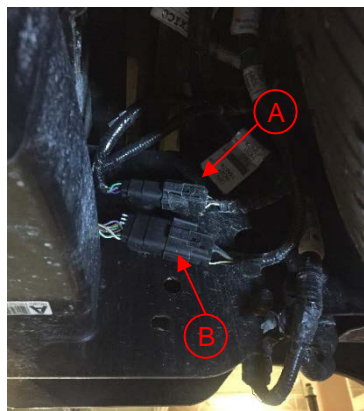
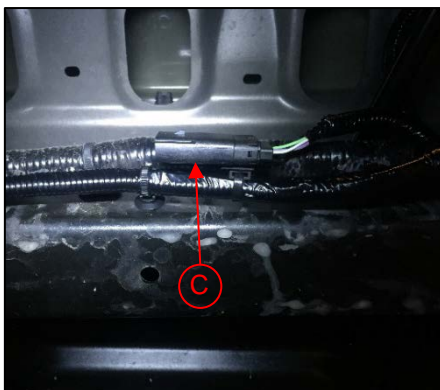
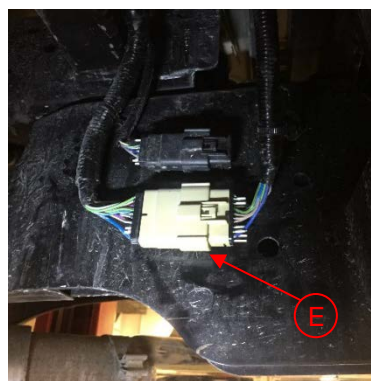
Figure 2: Box delete harness installation – jumper harness shown installed

Item	Description
A	Camera connector
B	Tailgate lock connector
C	Jumper Harness Connector (to camera kit)
D	Left / right tail lamp connector
E	Lighting connector

Ford rear view camera kit **JC3Z-19G490-B** (see contents in Figure 3), can be installed following kit instruction sheet included in kit. With box removed, it will be necessary to install harness **HC3Z-13A409-J** as shown in Figure 2. The camera kit harness (item F, figure 3) will then connect to the HC3Z-13A409-J harness as indicated in Figure 2. The jumper harness is equipped with fasteners to facilitate installation.

Note: Vehicles with power locking tailgate will have a second connector on the tailgate harness. To protect connector, install cap provided with vehicle (service part 4W1Z-14489-BA)

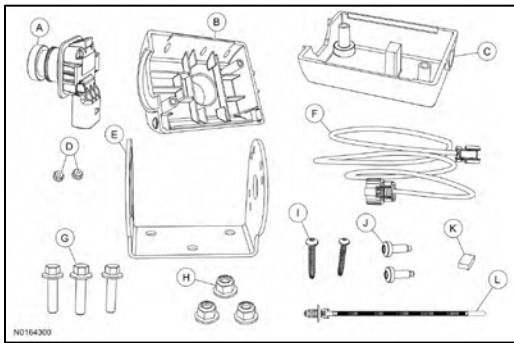
Figure 3: Camera Kit Contents

Item	Quantity	Description
A	1	Rear View Camera
B	1	Front Camera Case Half
C	1	Rear Camera Case Half
D	2	Screw Retaining nuts
E	1	Mounting Bracket
F	1	Wire Harness
G	3	Bolts
H	3	Nuts
I	2	Screws (Longer)
J	2	Screws (Shorter)
K	1	Foam Pad
L	1	Push Pin Tie Strap

A rear view camera kit for incomplete vehicles is available through Ford Service (part number **JC3Z-19G490-B** – *see figures 1 and 2*). Note that this same kit is also available as an orderable option (order code 872) with all pickup box Delete and Chassis Cab incomplete vehicles.

An adapter jumper harness (as mentioned previously) is required to allow this kit to be used on completed vehicles (Pickups with tail gate and or box removed.) The jumper is not included with the kit.

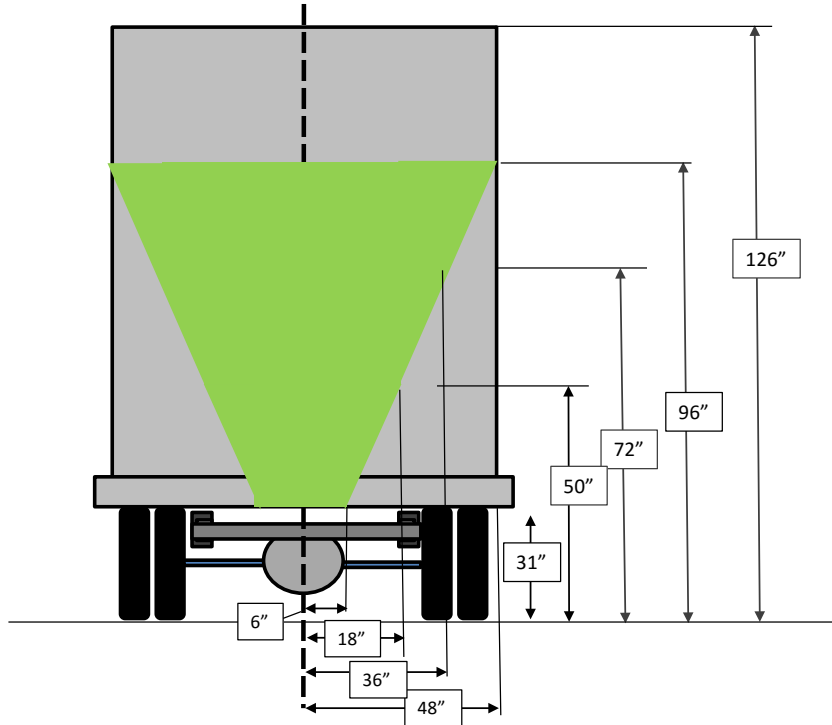
Figure 5: Coverage with 3.5 inch display, as shown at the rear plane of the vehicle

If equipped with a 3.5 inch rear view mirror display the camera included in kit is capable of complying with FMVSS 111 when mounted in the areas defined in Figure 5.

Compete Super Duty pickups are available with either the 3.5 inch rear view mirror display, 4.2 inch center stack display or the 8 inch center stack display. Based on Ford testing, the camera/display pairing is capable of meeting the backup camera field of view requirement of FMVSS 111 when mounted in the zones defined below.

Compliance to FMVSS 111 will be the responsibility of the upfitter who alters the vehicle. This information is provided for directional purposes only, based on testing done by Ford.

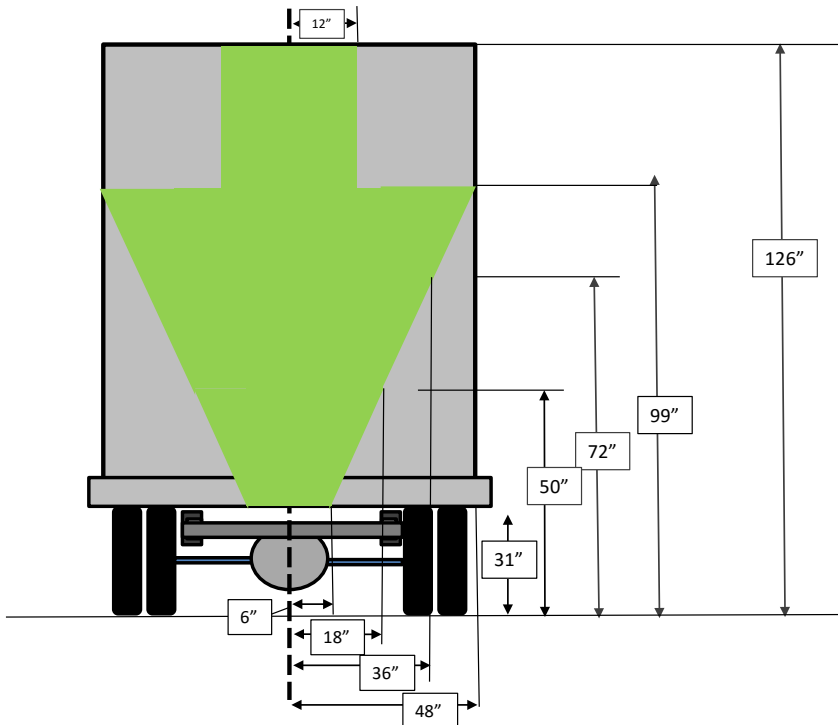
Figure 6: Coverage with 4.2 and 8 inch display, as shown at the rear plane of the vehicle

If equipped with a 4.2 inch or 8 inch display the camera included in kit is capable of complying with FMVSS 111 when mounted in the areas defined in Figure 6.
