QVM BULLETIN: Q-317

### 2021MY E-Series Cutaway Vehicles Equipped With Radio Delete And USB Cable

2021MY E-Series Cutaway Vehicles Equipped With Radio Prep-Package

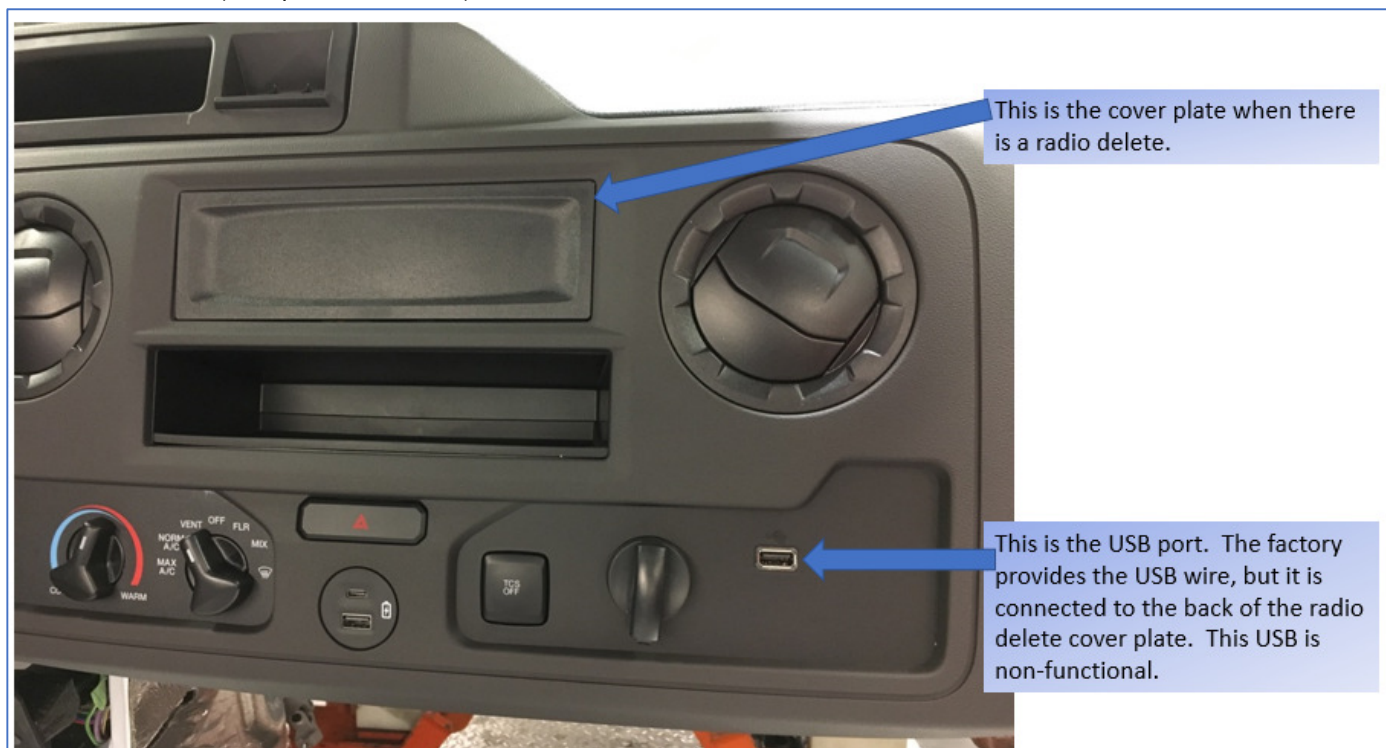
When the vehicle is ordered / equipped with the Radio Prep Package from factory, the USB connector and cable have been installed in the instrument panel. The USB port (shown in image below) will be **non-functional**. It is the Intermediate / Final Stage Manufacturer's responsibility to either remove the USB cable, or construct a cap / cover to hide USB port and USB symbol in the instrument panel, or inform the final customer that the USB port is non-functional.

The Intermediate / Final Stage Manufacturer can make the USB port/wiring functional once again by equipping with an aftermarket radio (or equivalent device) if desired.
